# DIP Switch Setting Guide

Adjusting Manual Gain Control

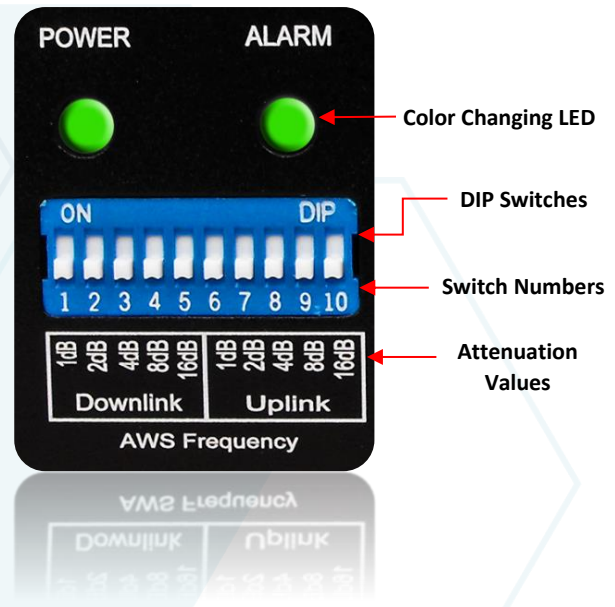
When an alarm is present, please attenuate the gain in increments of 2dB till the alarm is removed. To add attenuation, you need to move the DIP switches to the **ON** or **UP** position. Each switch number corresponds to an attenuation value. The total amount of attenuation set corresponds to the total value of the DIP switches that are in the ON position. **You will first add attenuation on the DL side (Switches 1-5) and then match the same values on the UL side (Switches 6-10) to make sure your system does not cause interference back to the cell tower.**

**PLEASE NOTE:** If any of the alarms go into MUTE or OFF, this is because of severe interference. You will first need to add attenuation (Typically more than 2dB) then power cycle the repeater using the ON/OFF Switch to take it out of the MUTE state (**OFF** then back **ON**). If the respective alarm LED is still OFF, then continue to add more attenuation and repeat the sequence of power cycling the repeater after each adjustment is made till the alarm LED turns solid green. If you suspect you have added too much attenuation, start to remove attenuation till the repeater just about goes into alarm, then add back 2dB of attenuation as a good setting. **Remember to match the UL.**

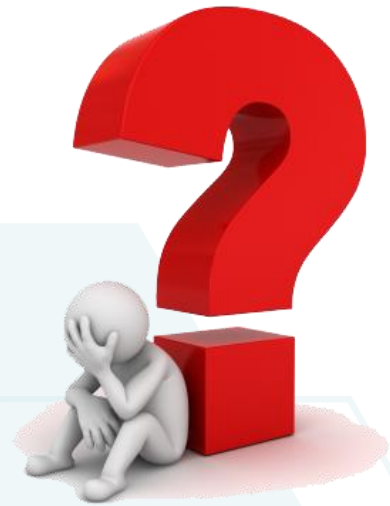
SYSTEM IN ALARM! WHY?

To determine the cause of your alarm LED showing an error, you can disconnect the indoor antenna / service line from the “**INDOOR**” port of the repeater. **If the LED does not change to green, then it's either a case of the input signal after passing through the pre-amp is now too strong or there is another antenna within a few feet of your donor antenna that's causing the interference.** If there are no other antennas close by, at this point you must attenuate the downlink DIP switches by 2dB increments till the LEDs turn green again. (**Switches 1-5**) After this, you must match the same attenuation value on the uplink side (**Switches 6-10**). Once complete, please reconnect the indoor antenna / service line again. If after connecting the indoor service line the alarm LED changes back to amber or red then signal oscillation is taking place.

Signal oscillation (OSC) is the result of your indoor and outdoor antennas being too close to each other and should be separated more or oriented away from the donor antenna. If you have confirmed your donor and service antenna placements are in optimal locations and the repeater is still in alarm, you then need to add more attenuation by 2dB increments till the LED's turn green again. Remember to rematch the uplink value to the downlink.
